## FIELD INSPECTION REPORT

| <b>Project Name:</b> | Mountain Valley Pipeline | <b>Inspector:</b> | Matthew Grant |
| <b>Inspection Date:</b> | Thursday, October 22, 2020 | <b>Project Contact:</b> | Brian Clauto |
| <b>Spread I: Franklin</b> | MP 271.3-272.9<br>AR- FR315<br>ATWS 356, 356A | <b>Weather:</b> | Dry |

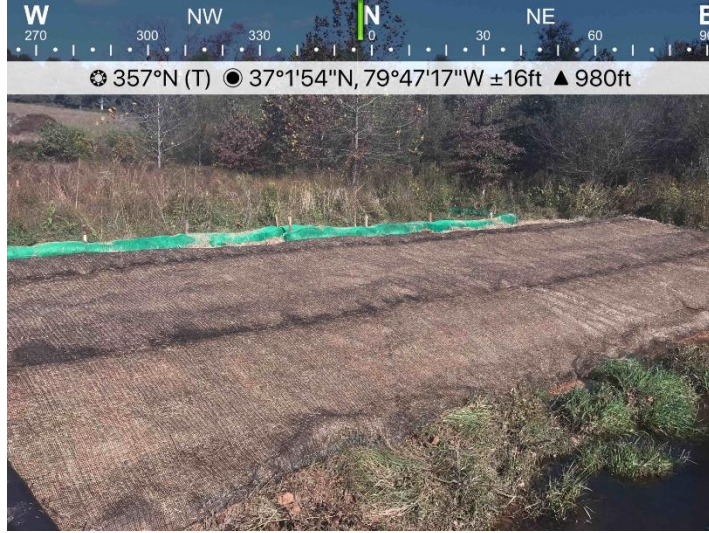
- Figure 1: Designated stream crossing S-A41 additional ECD's have been installed.

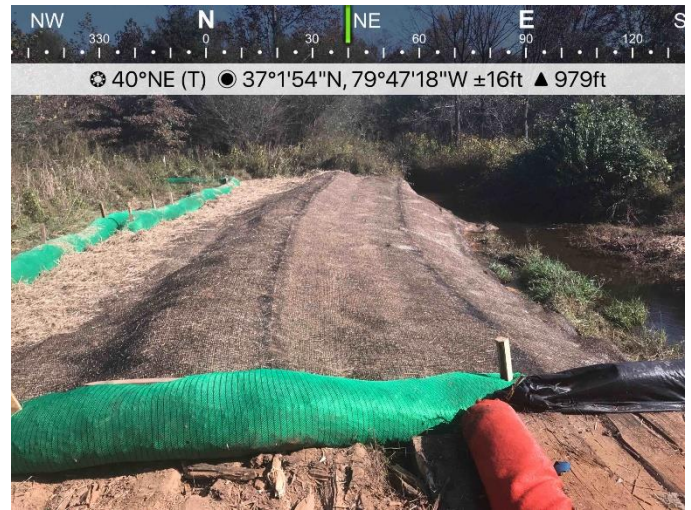
- Figure 2: Designated stream crossing S-A41 additional ECD's have been installed

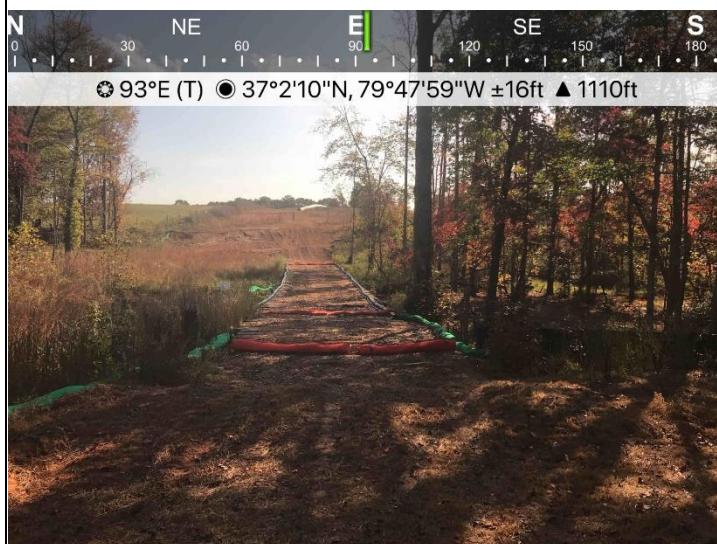
- Figure 3: Designated stream crossing S-A38, ECD's are in place.

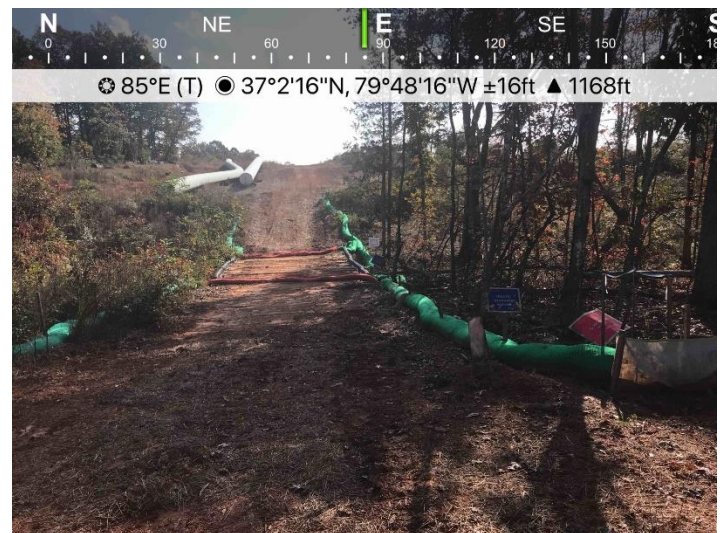
- Figure 4: Designated stream crossing S-A36, ECD's are in place.
